Manhole Inspection Summary

Manhole # S330__021MH

Insp Date: **3/19/08 10:50 AM**

Location Address: **810 leadenhall st**

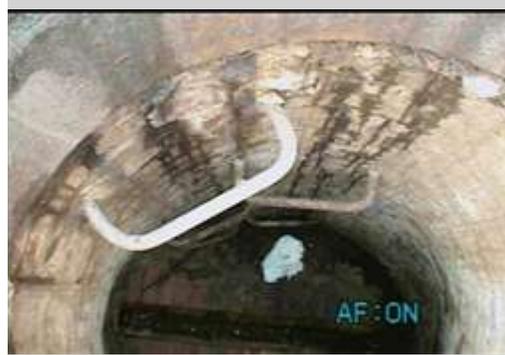
Defect 3

bench debris

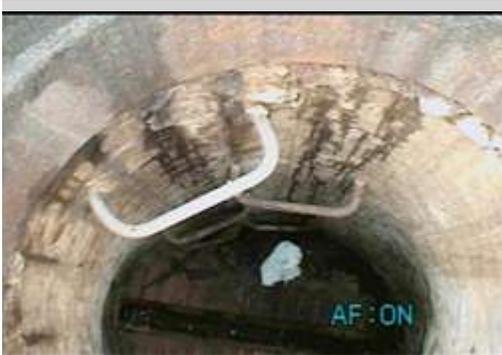
Defect 2

Steps

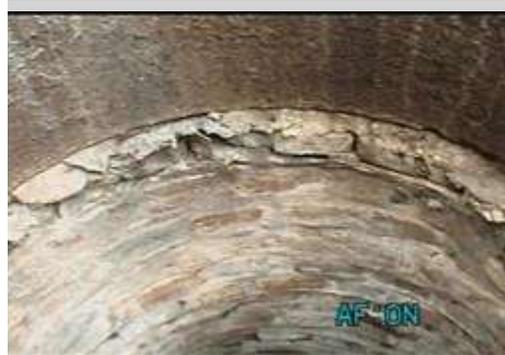
Defect 1

Infiltration: None **Joint** Cracks Mortar Roots **Wall**

Infiltration at frame

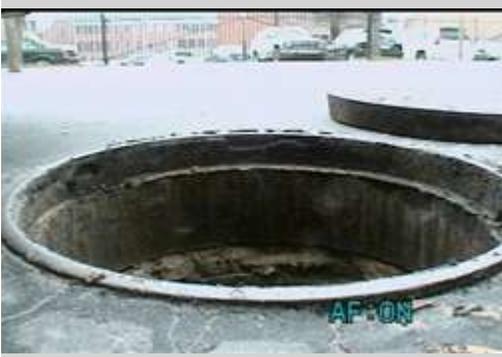
Defect

Condition: Sound Cracked Root Intrusion Loose Brick **Deteriorated**

deteriorated

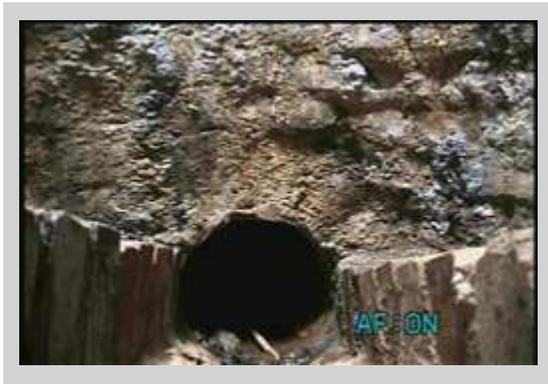
12 O'Clock Outflow

8 in. Circular Gravity Sewer
Pipe Out @ 12 O'Clock

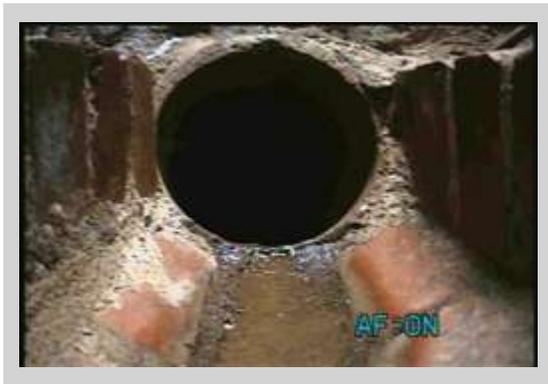
6 O'Clock Inflow

8 in. Circular Gravity Sewer
Pipe In @ 6 O'Clock
